Manhole Inspection Summary

Manhole # S11O__013MH

Location Address: **425 S Caton**

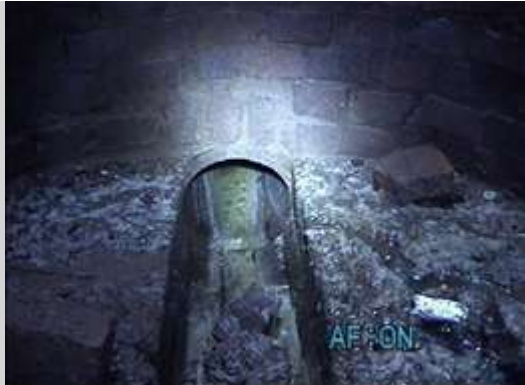
12 O'Clock Outflow

8 in. Circular Gravity Sewer
Pipe Out @ 12 O'Clock

Pipe Height: **8.4** (in.) Rod and Bar (Angled)
Pipe Material: **Clay** ☐ Pipe Lined
Invert Depth: **13.00** (ft.) Flow Characteristics: **Slow**
Deposits: ☒ None ☐ Mud ☐ ~~Gravy~~ ☐ **Debris** ☐ Grease
Silt Depth: **0** (in.) Deposits Extent:
Infiltration: **None** Pipe Seal Cond: **Sound**
